NATIONAL ADVISORY COMMITTEE FOR AERONAUTICS

MEASUREMENT OF FLYING QUALITIES OF A DOUGLAS A-26B AIRPLANE

III - STALLING CHARACTERISTICS

MEMORANDUM REPORT

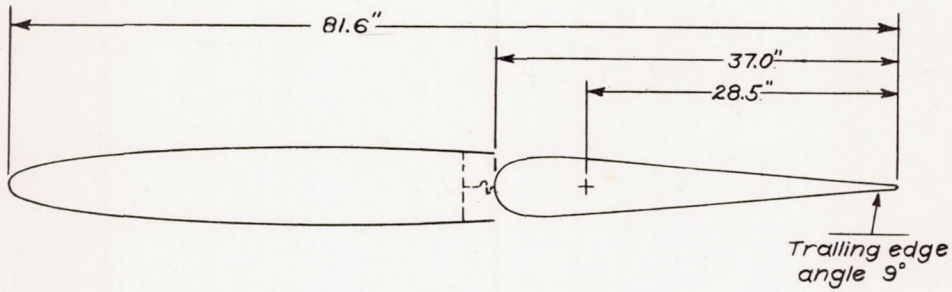
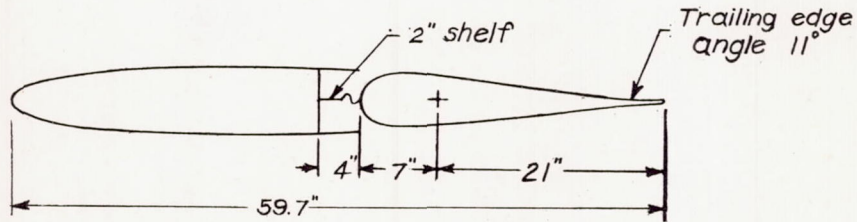
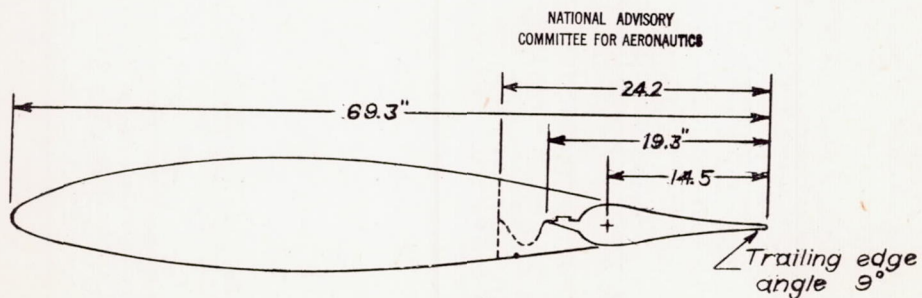
Figure 1.- Concluded.

Section vertical tail 49 inches from tip

Section of horizontal tail 76.5 inches from airplane center line

Wing section 352 inches from airplane center line

(b) Sections through vertical tail, horizontal tail, and wing at aileron. Douglas A-26B airplane.

Figure 1 shows a three-view drawing of the airplane and sections of the wing and tail surfaces. A description of the airplane and several photographs of the airplane are given in reference 1. Figure 2 presents photographs of the wing surface condition and the oil-cooler air intake. Figure 3 is a side-view photograph of the airplane showing the location of the service airspeed head. The airplane was equipped with double-slotted flaps. Figure 4 shows a section of the flap at various deflections.

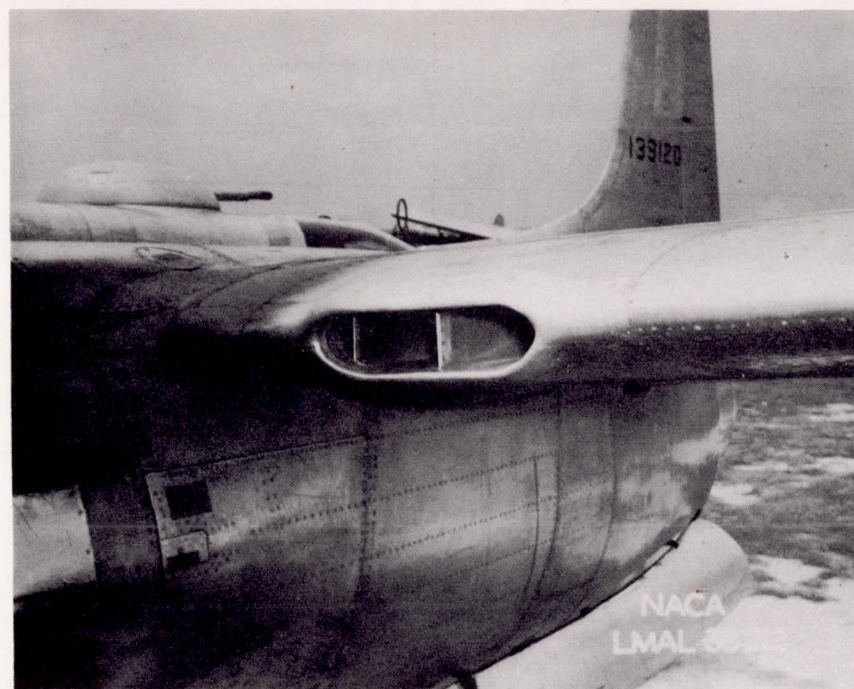
(a) Leading edge at oil-cooler duct.

Figure 2.- Photographs showing surface condition of Douglas A-26B wing.

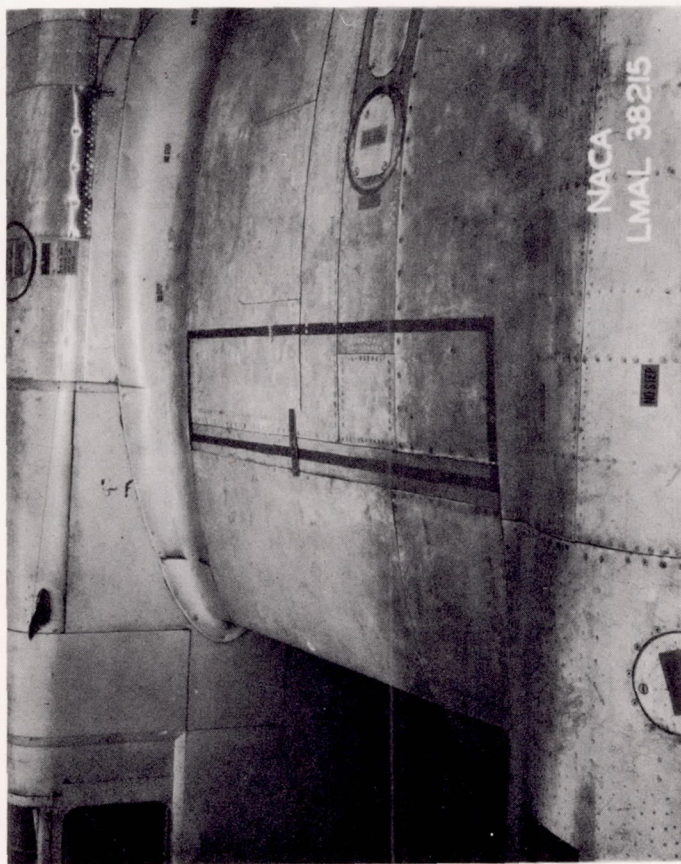
(b) Top surface inboard of nacelle.

Figure 2.- Continued.

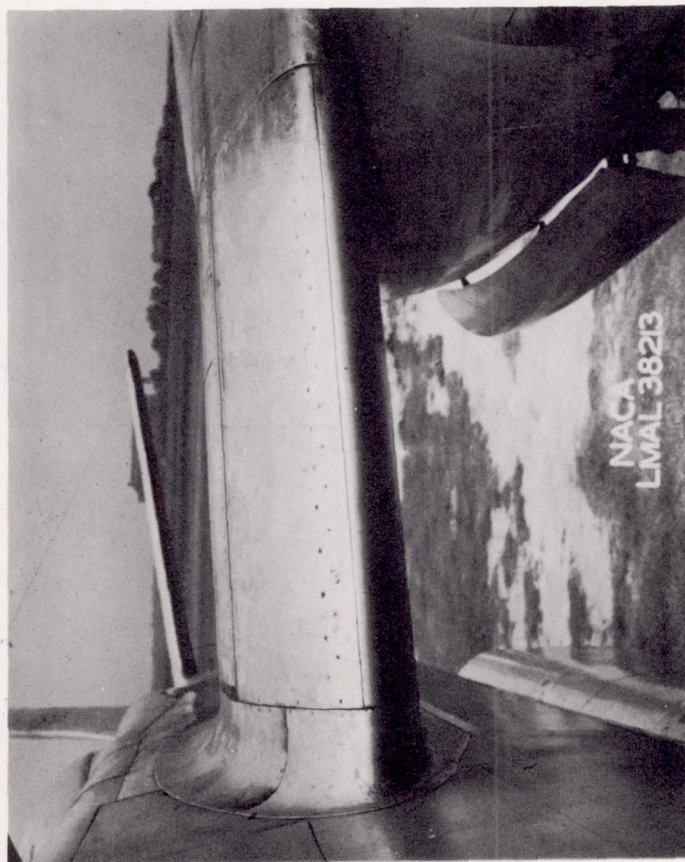
(c) Leading edge inboard of nacelle.

Figure 2.- Concluded.

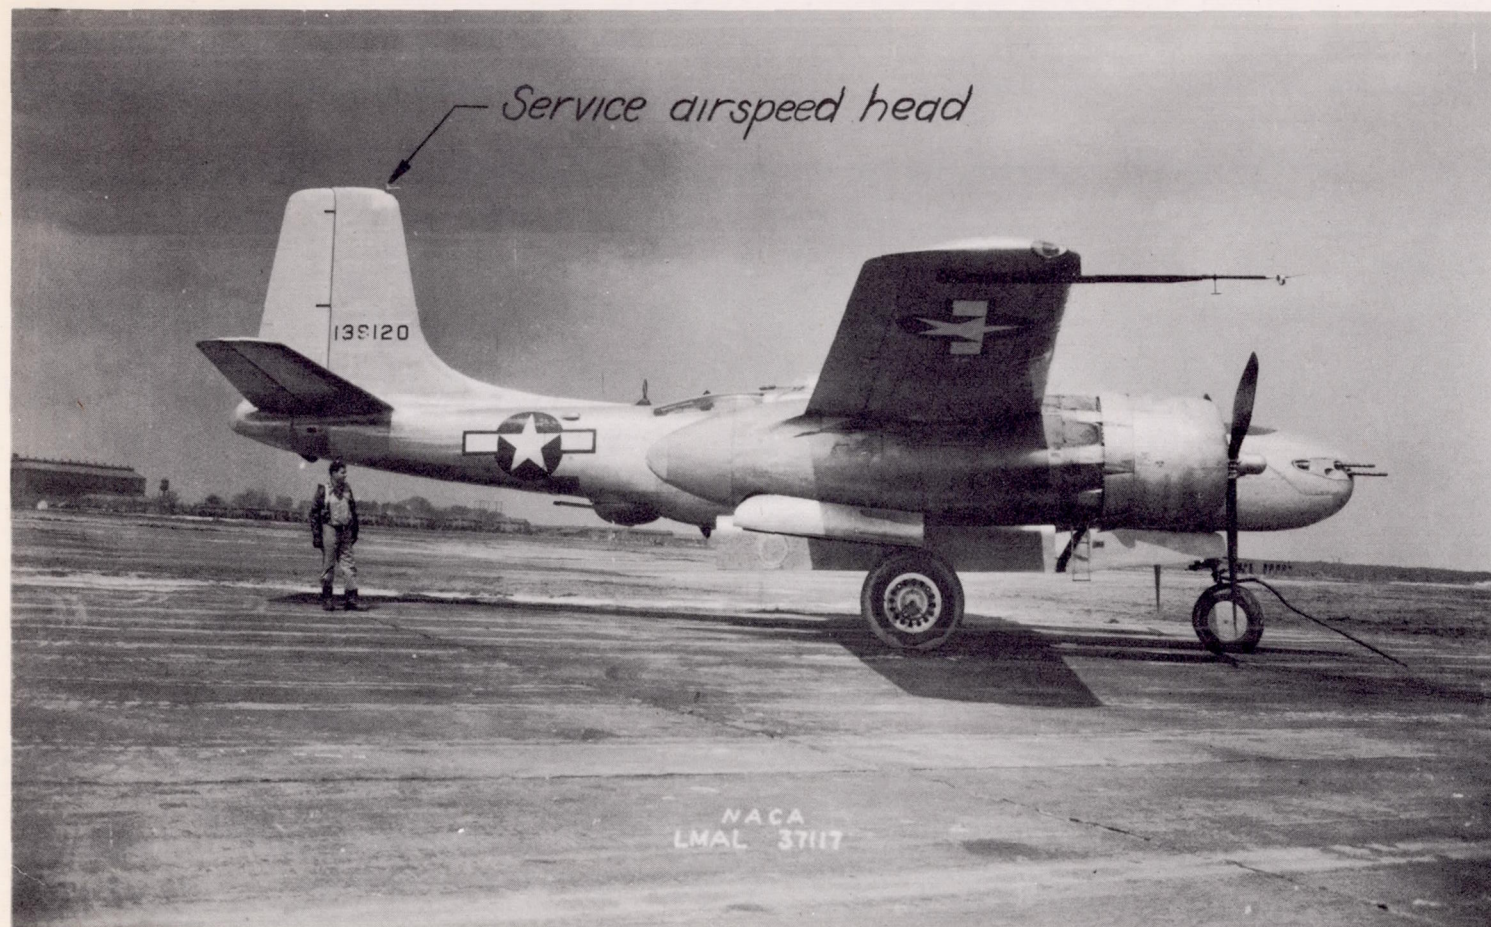
Figure 3.- Side view of Douglas A-26B airplane showing service airspeed head.

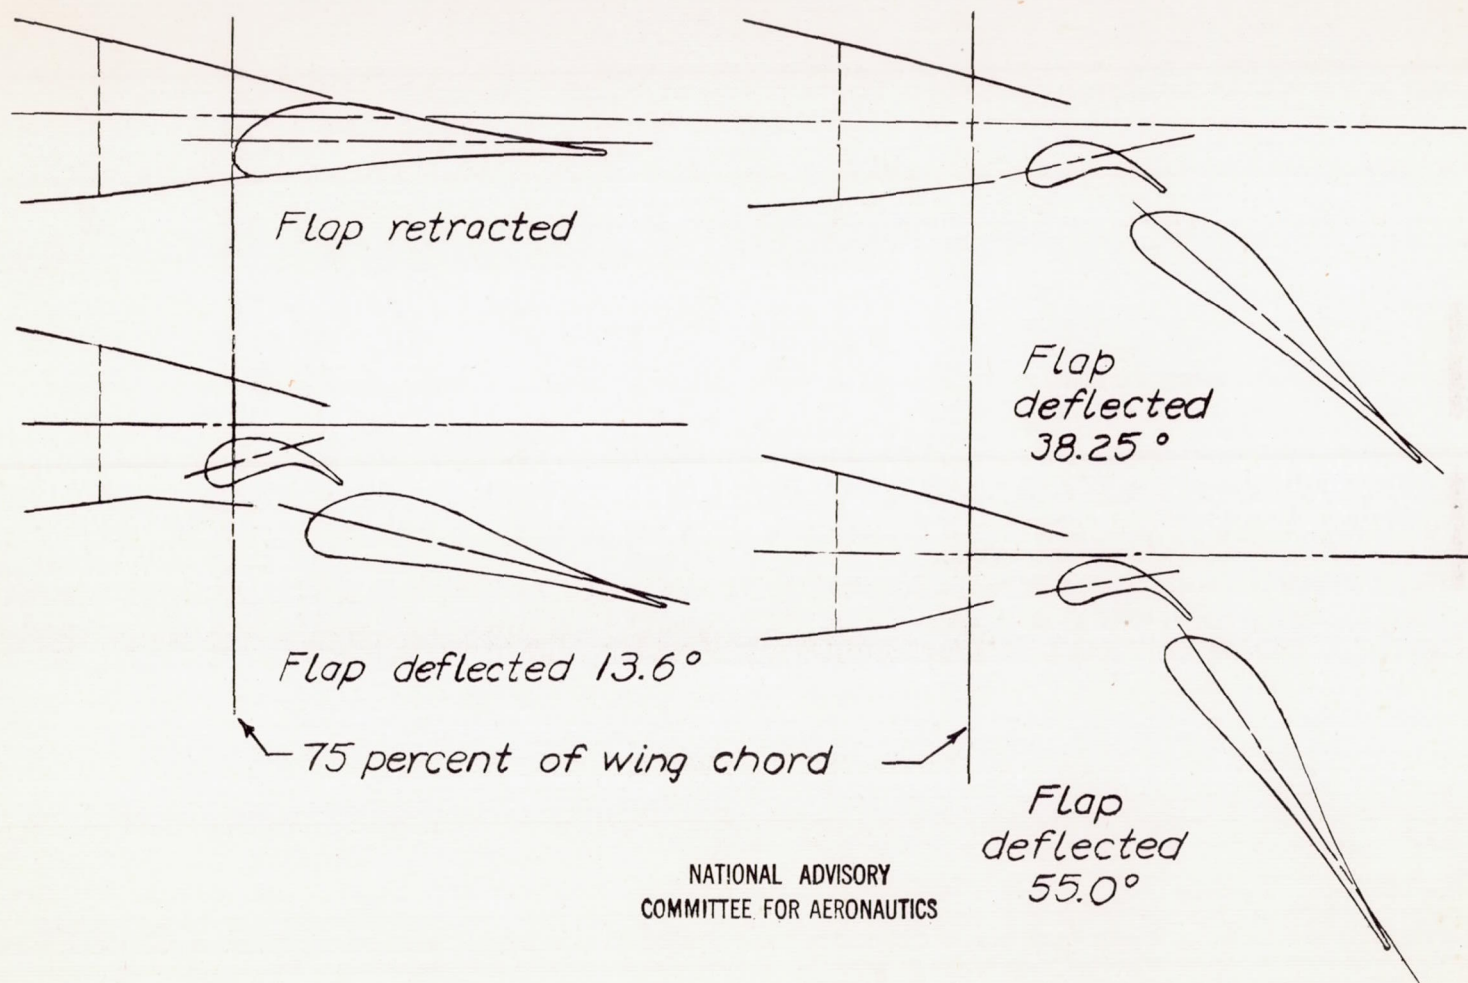
Figure 4.- Section through flap at various deflections.

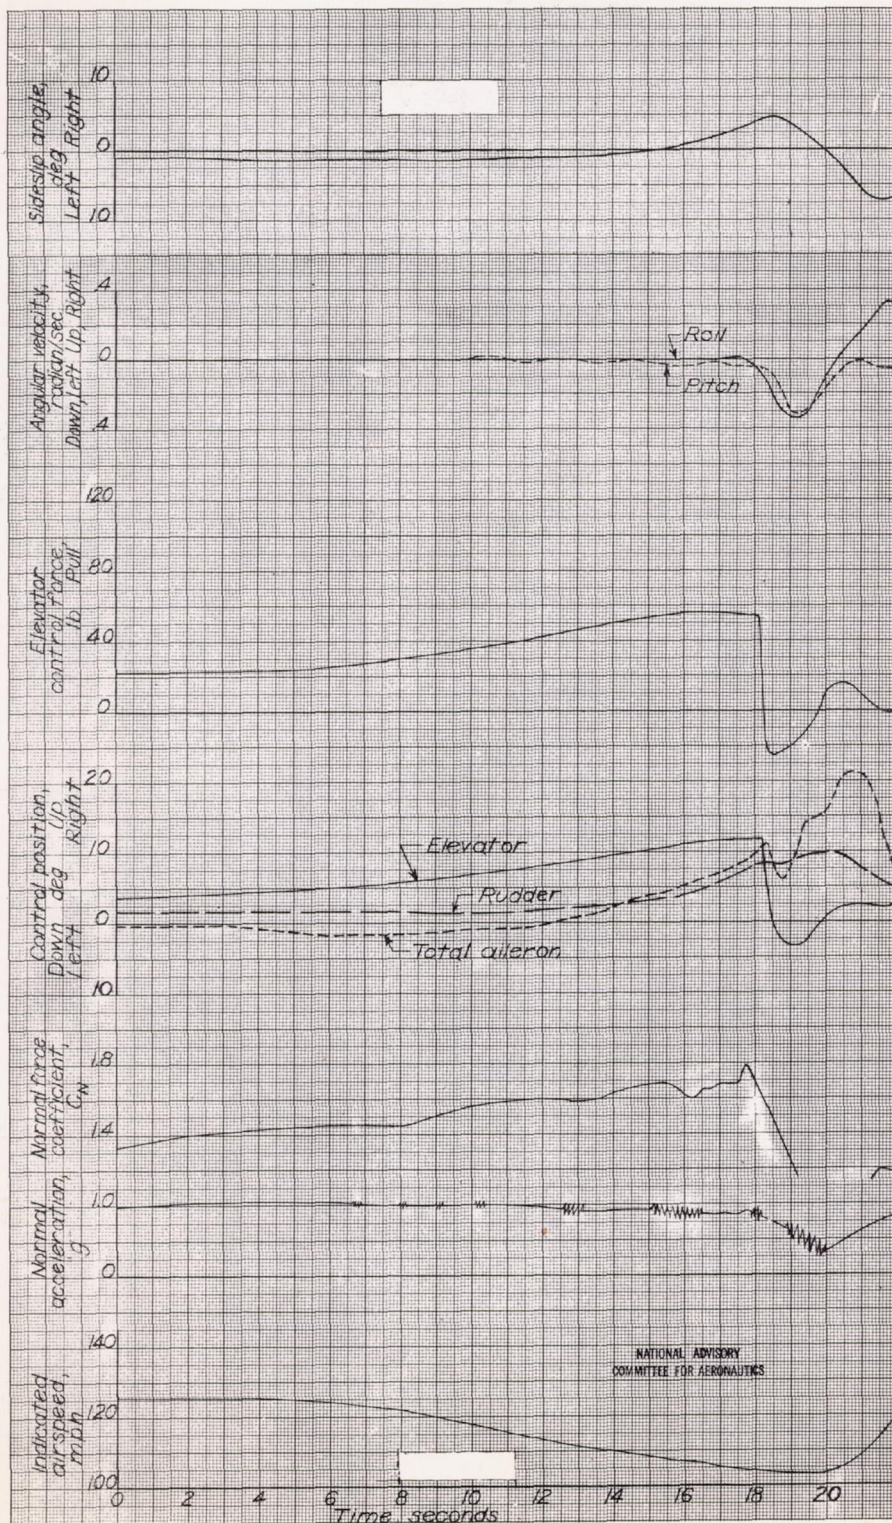
Figure 5.- Time history of a stall in the rated-power clean condition (flaps up, landing gear up, cowl flaps closed, oil cooler one-half open, 41.5 in. Hg. at 2400 rpm, c.g. at 23 percent M.A.C.), Douglas A-26B airplane.

The straight-flight stalling characteristics were investigated in the rated power-clean, cruising, gliding, approach, landing, wave-off, and take-off conditions. The stalls were made by gradually reducing the airspeed while attempting to hold straight flight. Figures 5 through 8 are time histories of stalls in the rated power-clean, gliding, landing, and wave-off conditions. Figures 9, 10, and 11 are tuft studies showing the stall progression over the wing in the gliding and landing conditions, and in the flaps-up condition with one propeller feathered and the other engine delivering rated power. The reason for including a tuft study with one propeller feathered was to make possible a comparison with wind-tunnel studies of stalling over the lip of the wing duct which were made with propellers removed. Tuft studies were not made with power on, because the A-26B airplane climbed away from the observing airplane in the stall approaches.

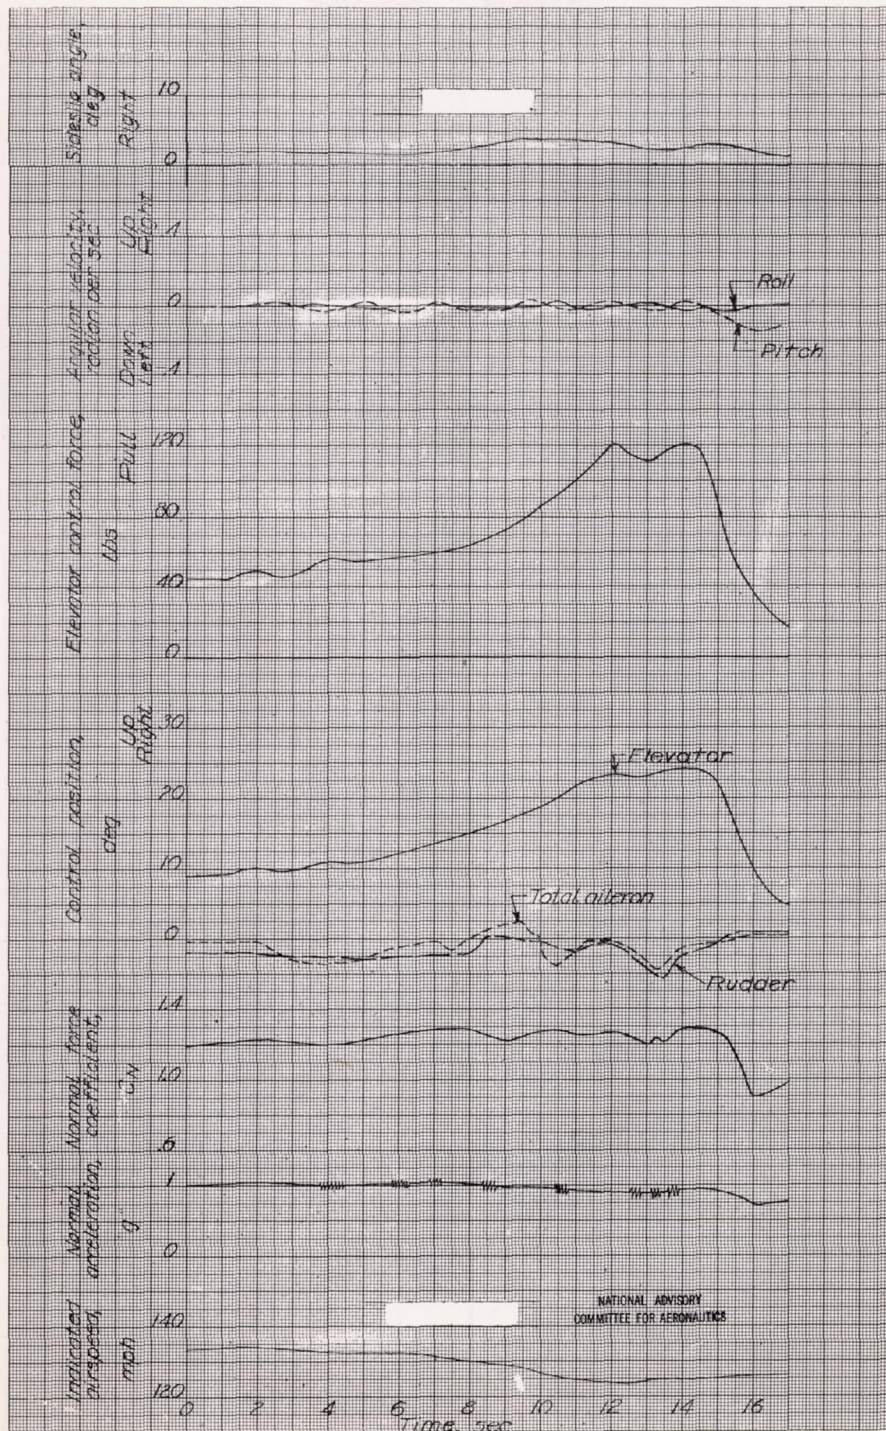
Figure 6.- Time history of a stall in the gliding condition (flaps up, landing gear up, cowl flaps closed, oil cooler one-half open, engines idling, c.g. at 23 percent M.A.C.), Douglas A-26F airplane.

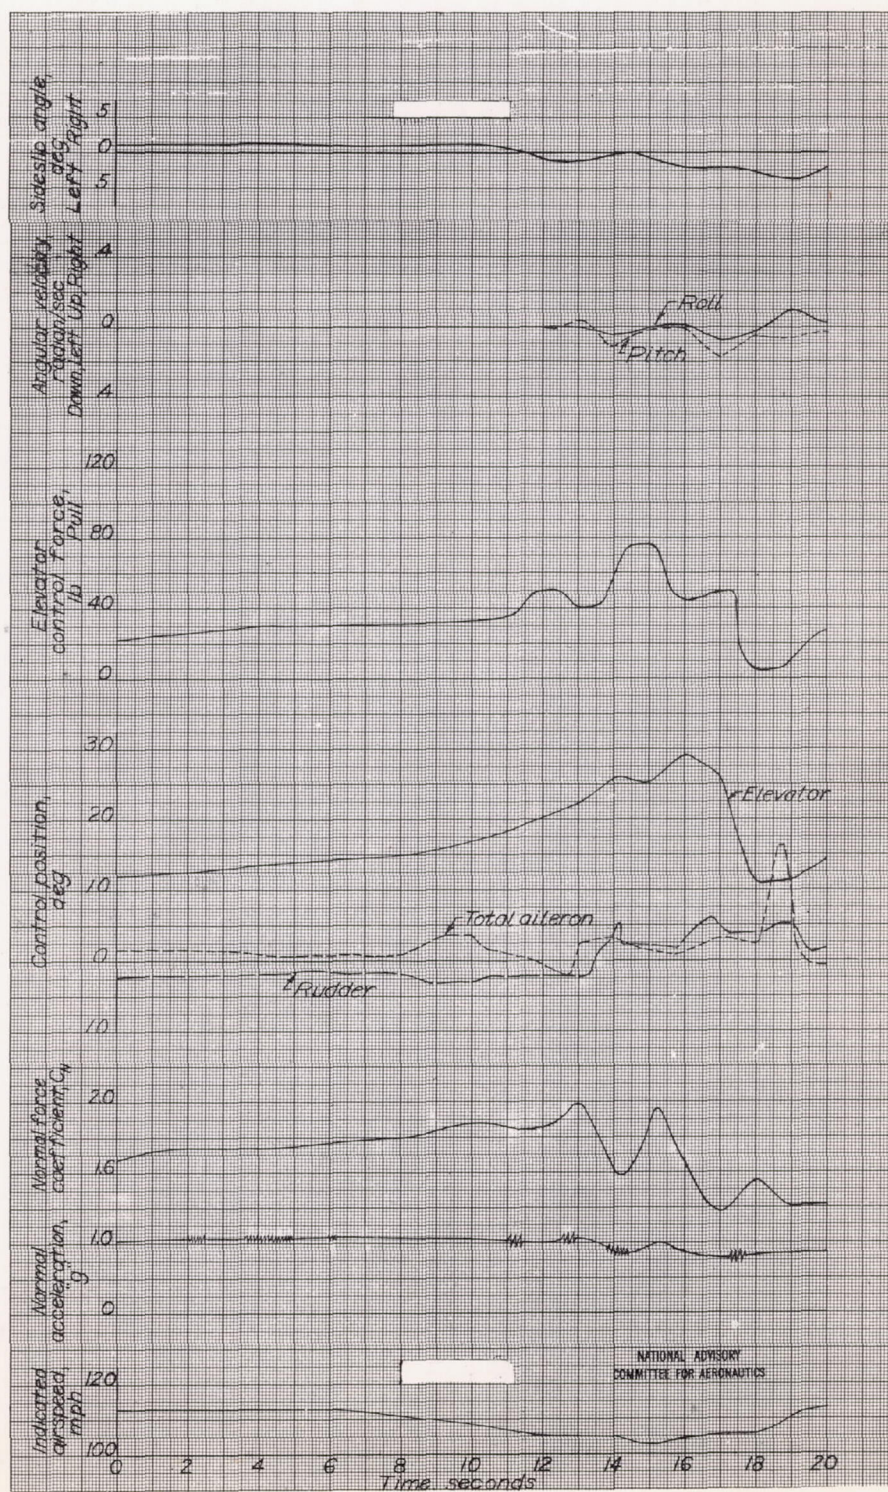
Figure 7.- Time history of a stall in the landing condition (flaps down, landing gear down, cowl flaps open, oil cooler one-half open, engines idling, c.g. at 23 percent M.A.C.), Douglas A-26B airplane.

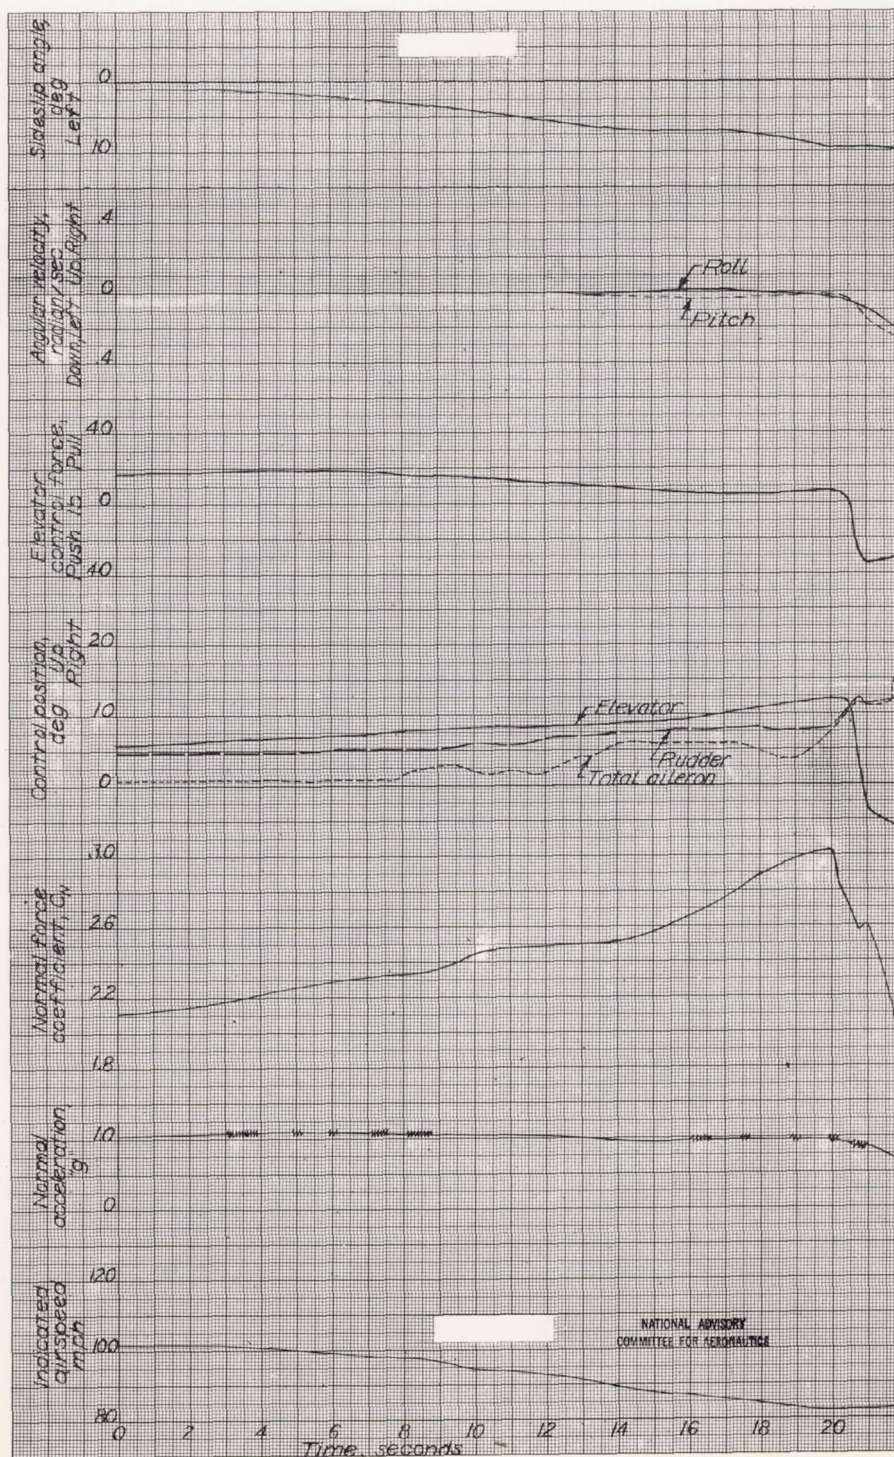
Figure 8.- Time history of a stall in the wave-off condition (41.5 in. Hg. at 2400 rpm, flaps down, landing gear down, cowl flaps open, oil cooler one-half open, c.g. at 23 percent M.A.C.), Douglas A-26B airplane.

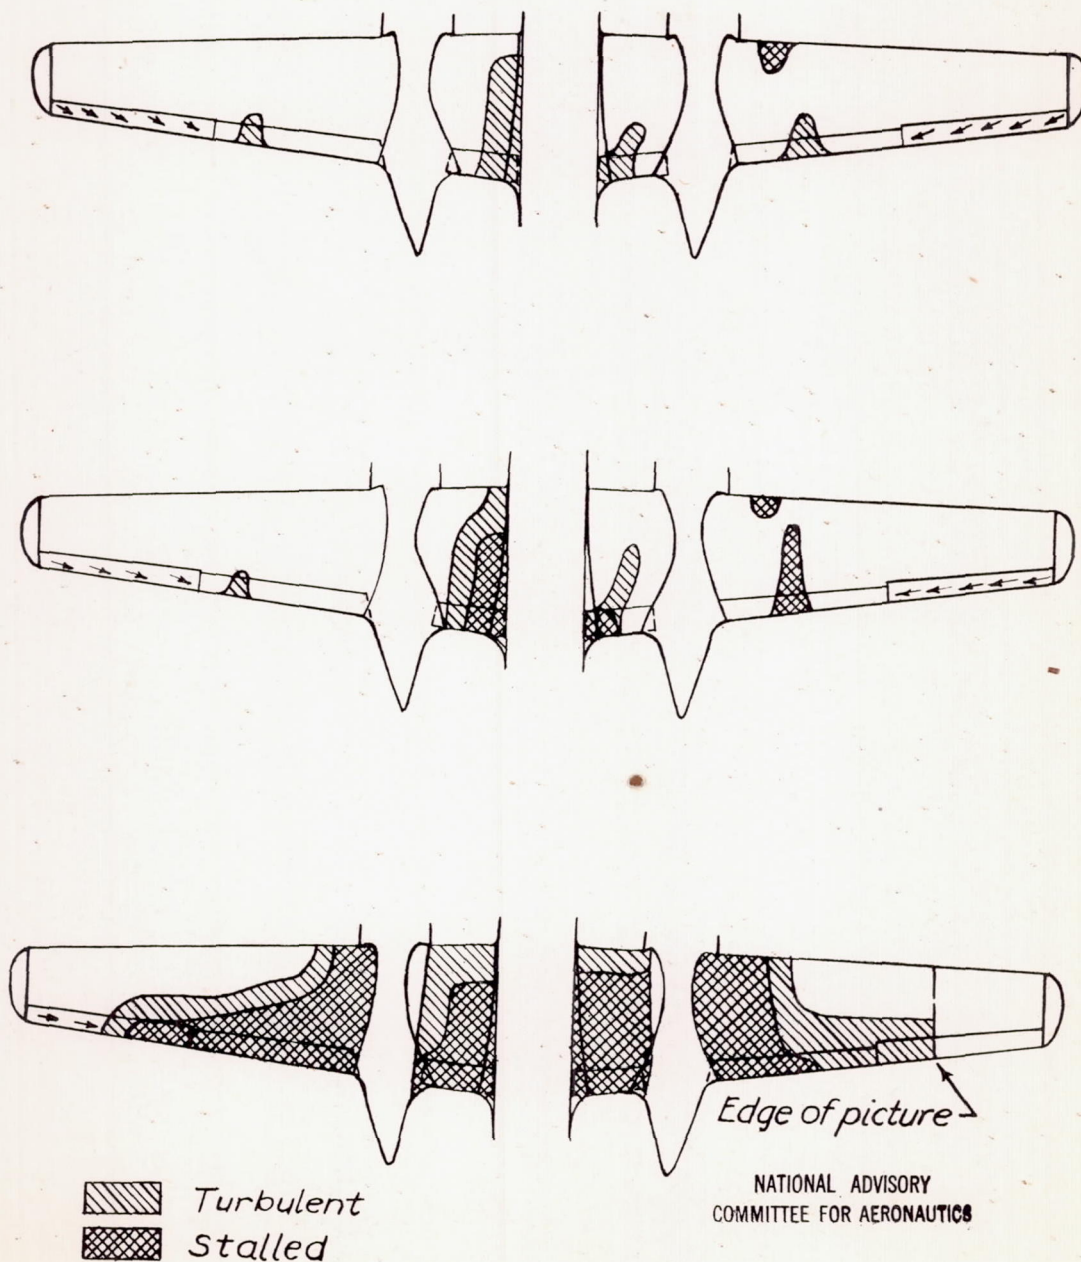
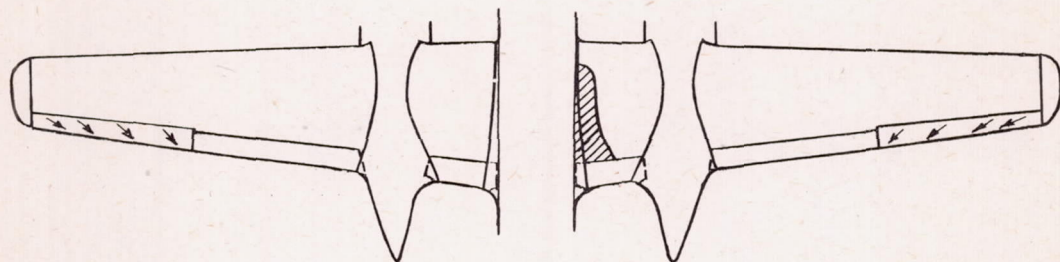
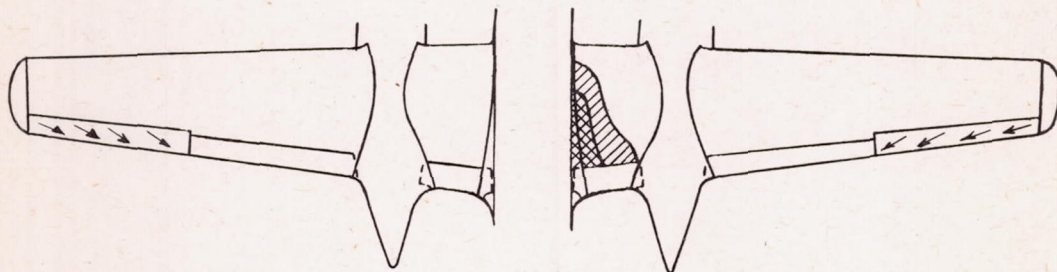
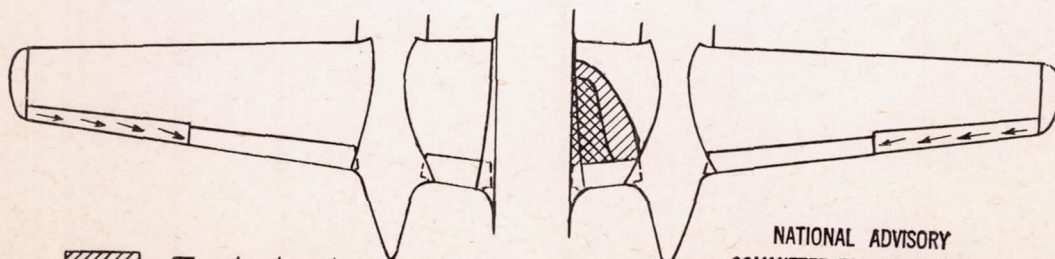
Figure 9.- Diagrams of stall progression in the gliding condition engines idling, flaps and landing gear up, cowl flaps closed, oil cooler one-half open), Douglas A-26B airplane.

*Left wing between nacelle and fuselage and right wing inboard flap not visible throughout run.*

2. The tuft studies (figs. 9, 10 and 11) show that root stall occurred. The root stall decreased the downwash at the tail and thus accounted for the increase in pull forces and up-elevator deflections required at the stall. A premature breakdown of flow over the right-wing duct lips was noted in the gliding condition, but this flow breakdown did not occur with the flaps down and probably would not occur with power on.

3. With engines idling, flaps up or down a pitching oscillation occurred at the stall. Figure 9 shows the stall pattern for the flaps-up, engines idling condition to be symmetrical. Because of the symmetrical stall pattern no abrupt rolling motions occurred. Recovery from the pitching oscillation could be promptly effected by application of down elevator.

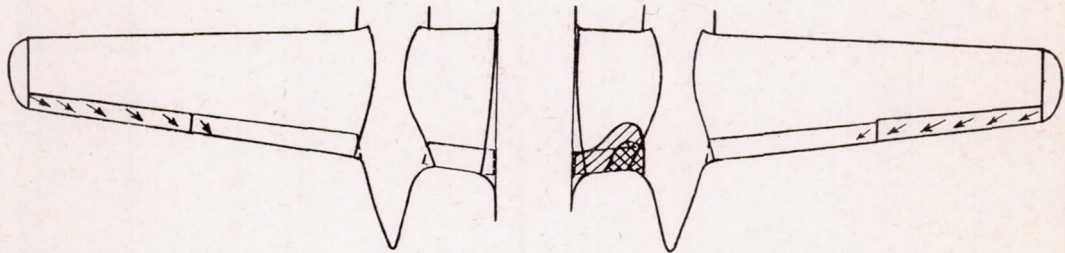
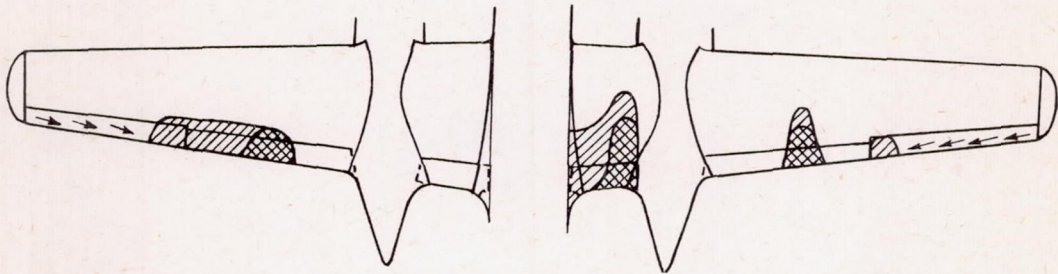
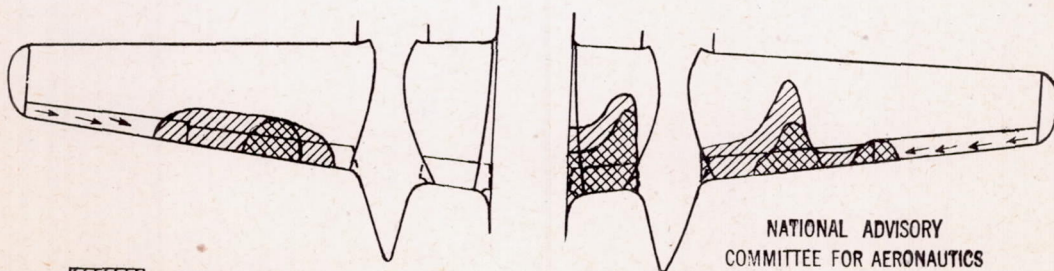
Figure 10.- Diagrams of stall progression in the landing condition (engines idling, flaps and landing gear down, cowl flaps closed, oil cooler one-half open), Douglas A-26B airplane.

*Left wing between fuselage and nacelle not visible throughout run*

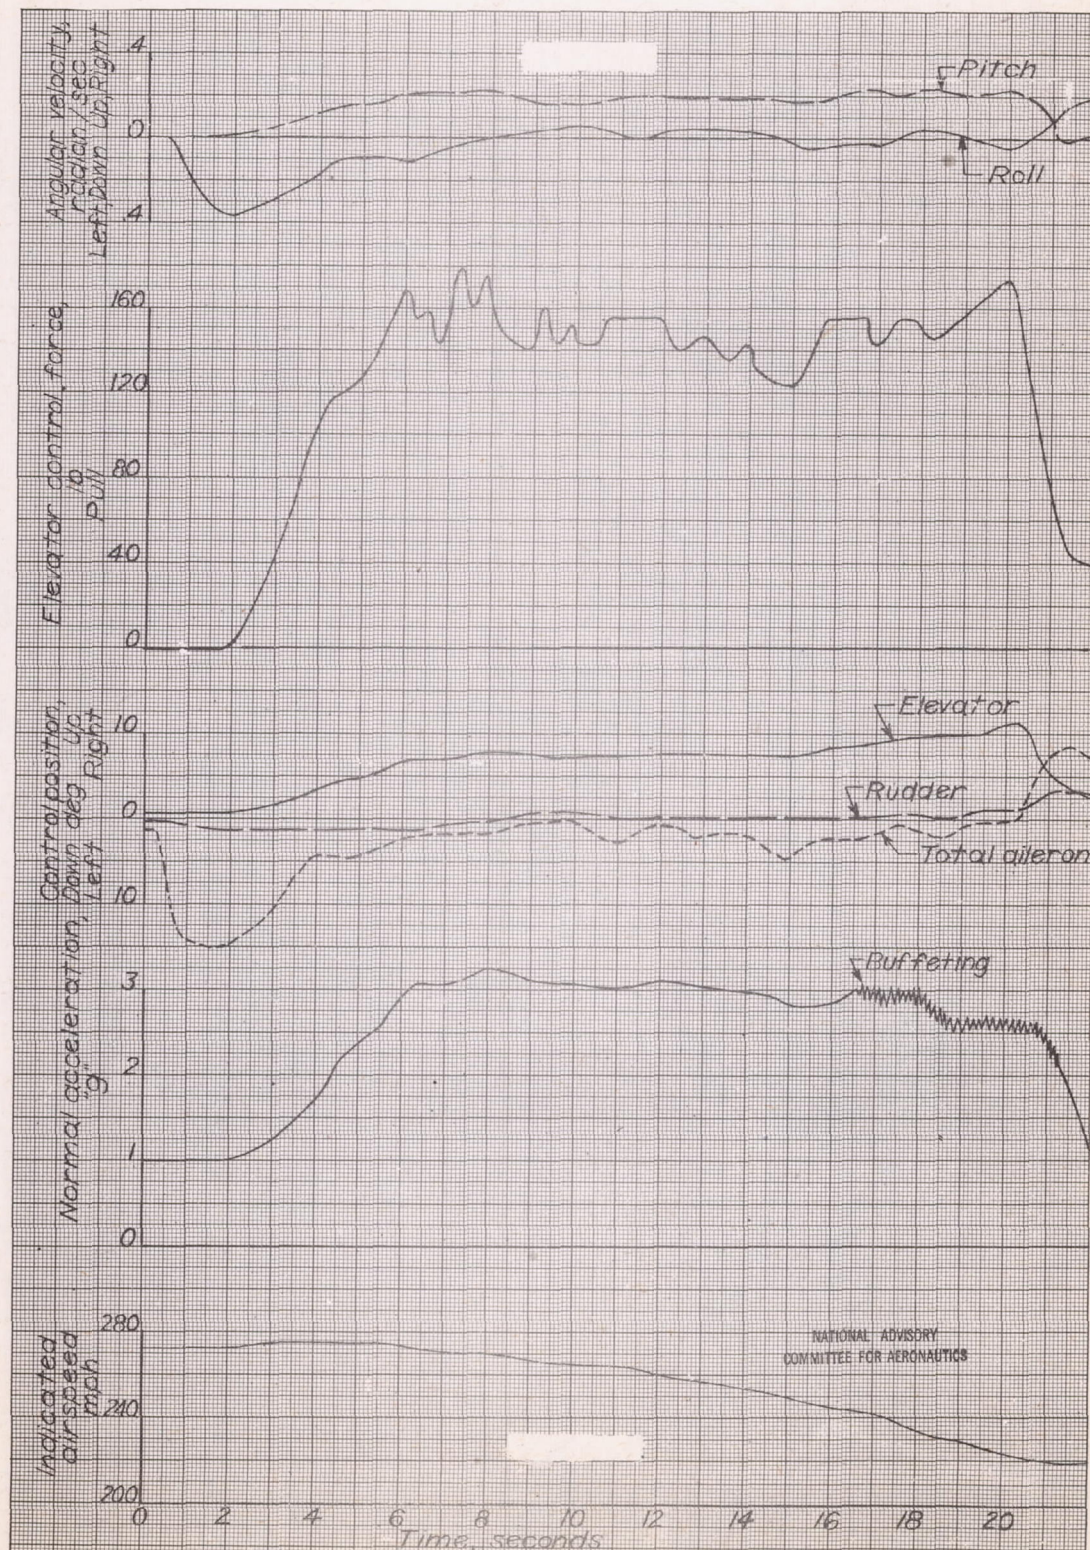
Figure 12.- Time history of a wind-up turn to the stall in the rated power, clean condition (41.5 in. Hg. at 2400 rpm, flaps up, landing gear up, cowl flaps closed, oil cooler one-half open), c.g. at 23 percent M.A.C., Douglas A-26B airplane.

The stalling characteristics in turning flight were investigated in the rated power-clean condition. In these tests the airplane was trimmed at the maximum speed for level flight and constant acceleration turns were made as the airspeed was gradually reduced to the stall warning. Figure 12 is a time history of a typical left turn in which this procedure was followed.

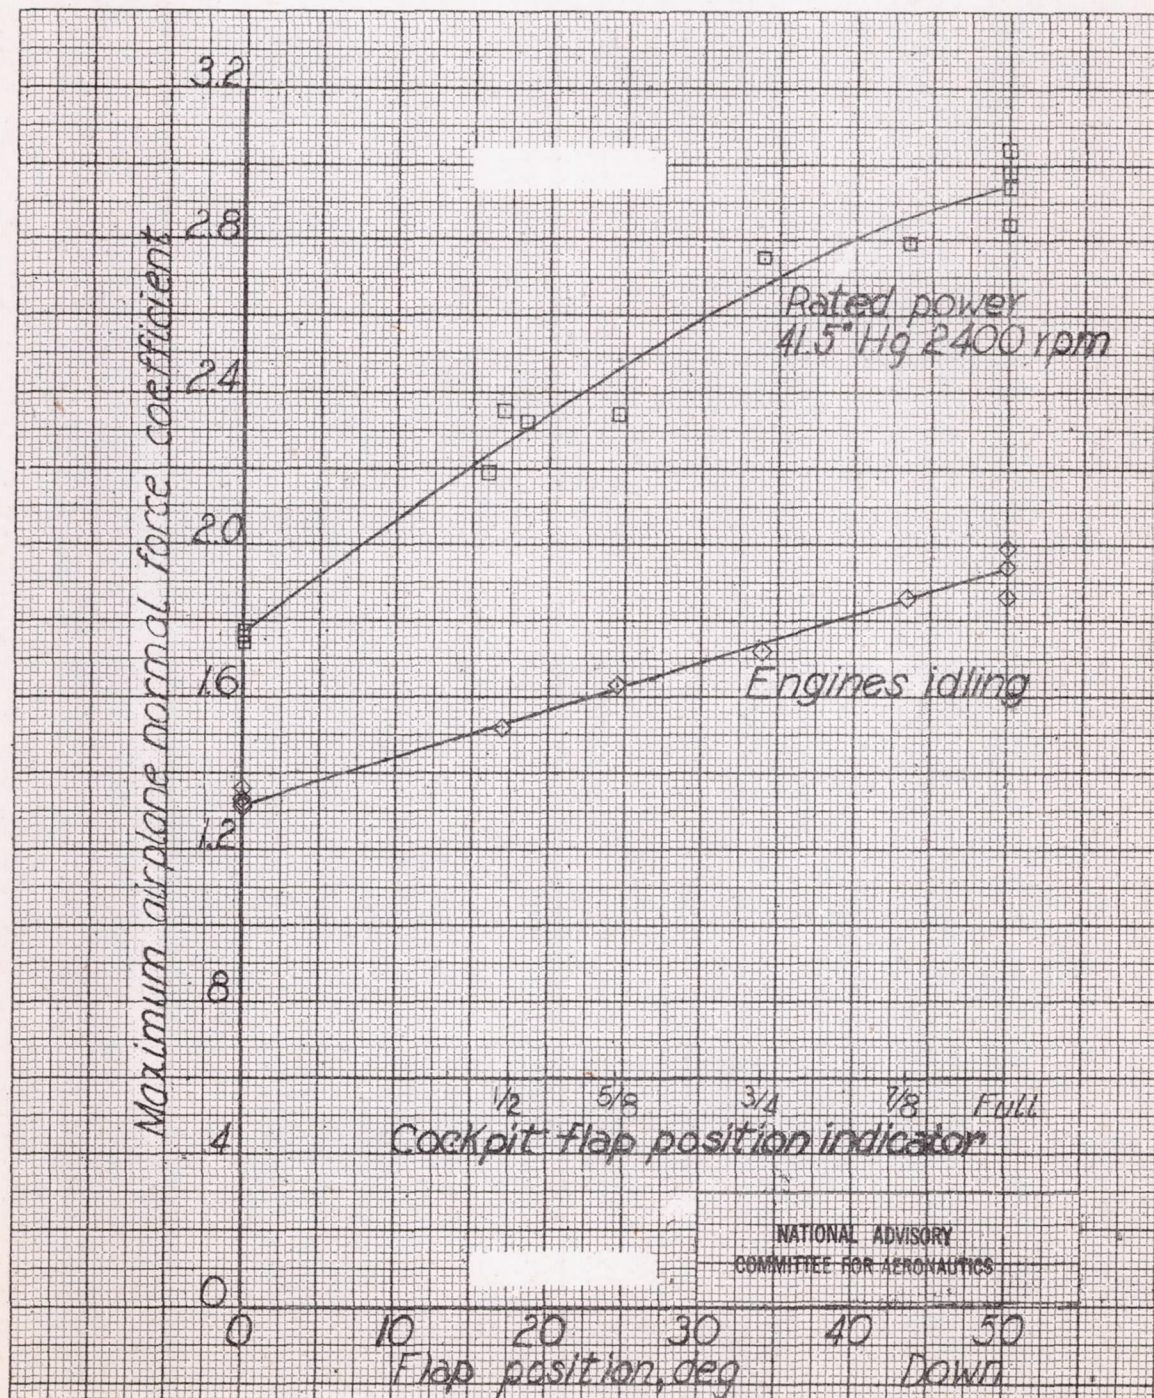
Figure 13.- Variation of maximum airplane normal force coefficient with flap position. Douglas A-26B airplane.

Table I presents the weights, center-of-gravity positions, and flap and landing-gear positions corresponding to the maximum normal-force coefficients obtained. Figure 13 shows the variation of maximum normal-force coefficient with flap angle with the engines idling and also with rated power.

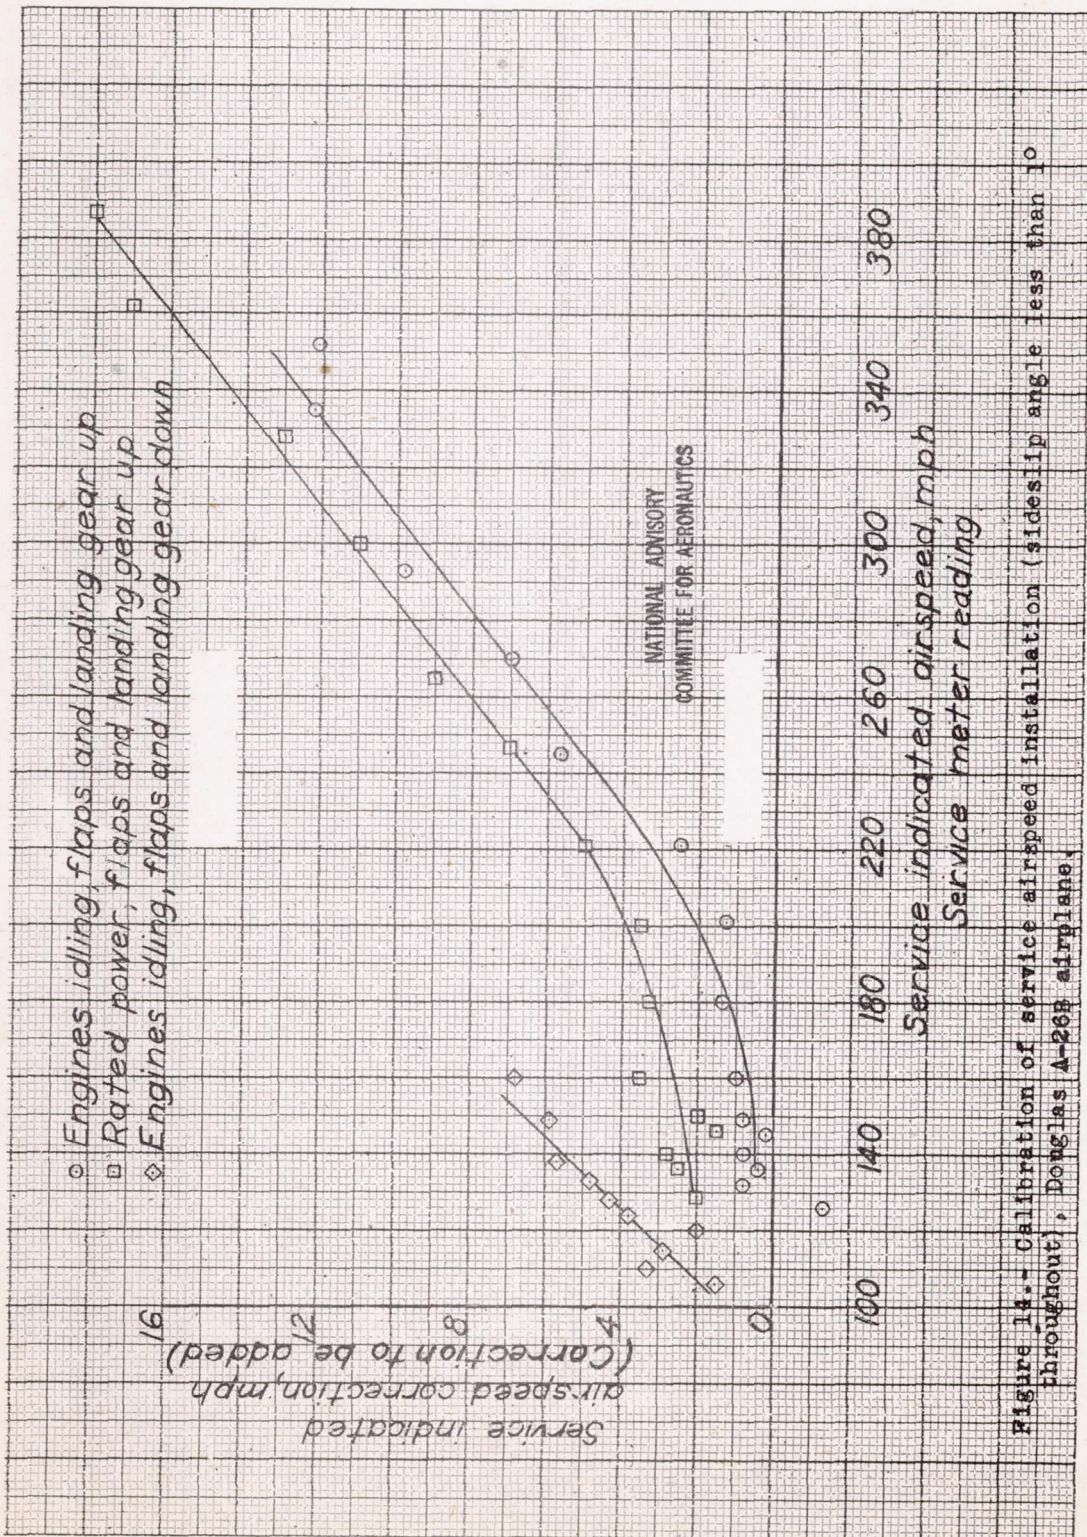
Figure 14.-- Calibration of service airspeed installation (sideslip angle less than 10 throughout), Douglas A-26B airplane.

On one flight the pilot used a sensitive airspeed meter connected to the service airspeed installation. By comparing the airspeeds recorded on the pilot's notes with those obtained from the NACA recorder, which was connected to the swiveling static head and the shielded total head, a calibration of the service airspeed installation was obtained. Figure 14 is a plot of the error in the service airspeed installation against service indicated airspeed. In the preparation of this figure account has been taken of the scale error of the particular meter used. Corrections were applied to the airspeeds from the NACA recorder for position error and for the effect of compressibility at sea level. Data were used only from runs in which the sideslip angle was less than  $1^\circ$ . The airspeed indicated by the service airspeed installation was approximately 10 miles per hour low at 300 miles per hour and the error increased with speed.

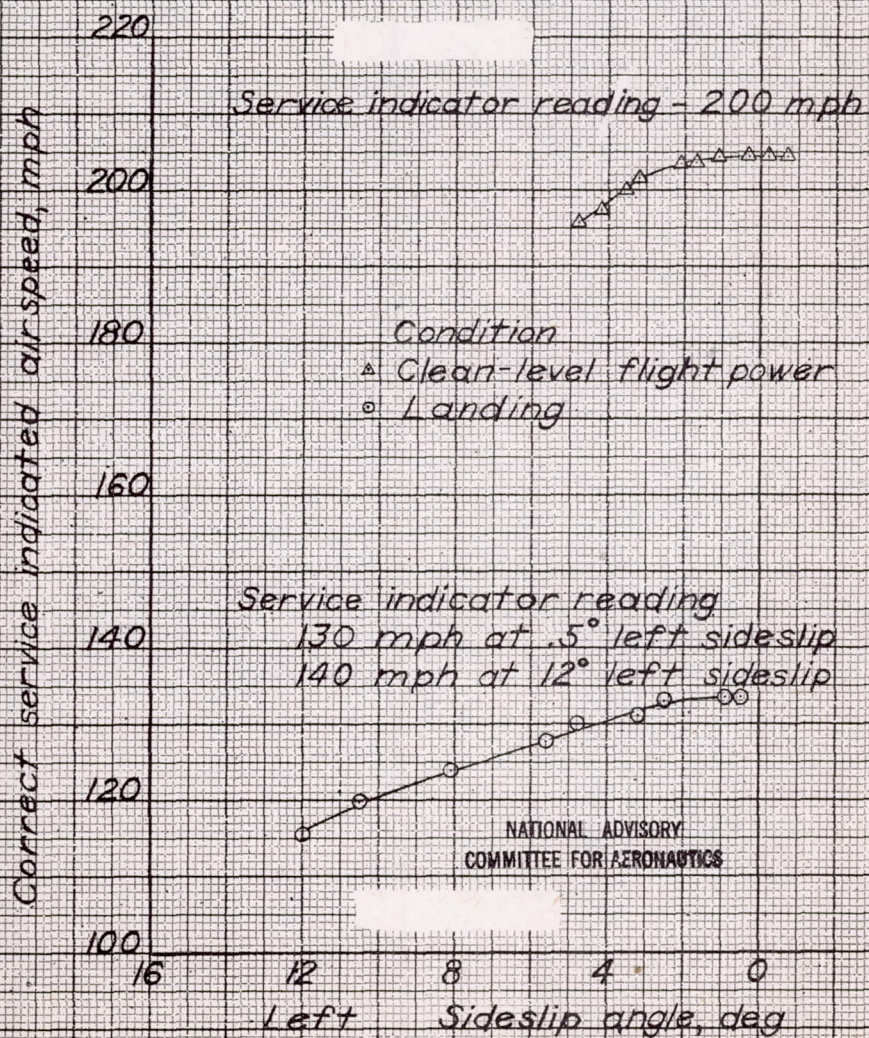
Figure 15.- Variation of correct service indicated airspeed with sideslip angle while the pilot attempted to hold a constant airspeed indicator reading in gradually increasing sideslips, Douglas A-26B airplane.

Figure 15 illustrates the large error in indicated airspeed due to sideslip at low speeds. At 140 miles per hour in the landing condition the service airspeed indicator read approximately 25 miles per hour high when the angle of sideslip was  $12^\circ$ . This error would probably be considerably reduced if the pitot-static head were mounted ahead of the wing tip instead of on the vertical tail. The pilot considered the sensitivity of the airspeed system to yaw objectionable especially during landings.
